NASA SAFETY CENTER

SYSTEM FAILURE
CASE STUDY

June 2017 Vol. 10 Issue 1

Smoke and Mirrors: What Went Wrong at L'Enfant Plaza

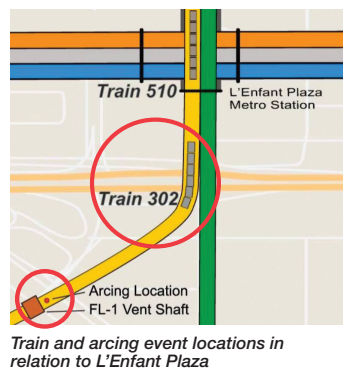
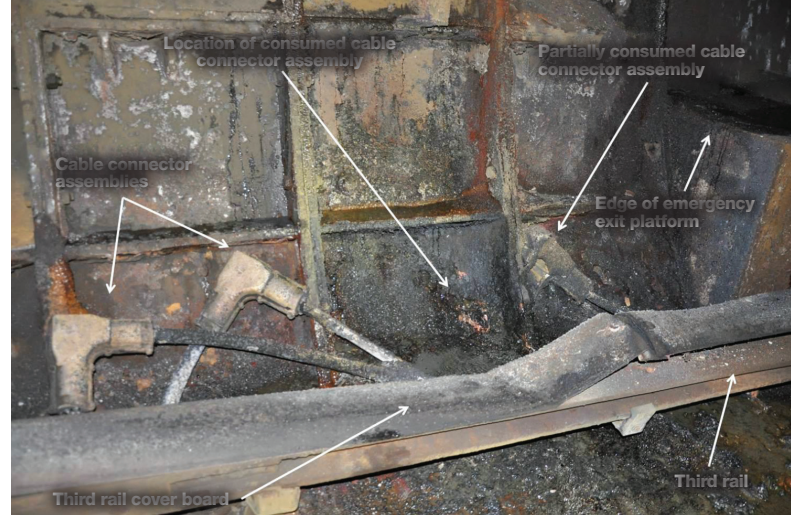
Fire-damaged cables and cable connector assemblies

According to NTSB investigators, “electrical arc tracking at improperly constructed power cable connector assemblies” within the third rail electrical power cable system caused a short circuit that generated fire and smoke in the tunnel. About 16 feet of third rail power cables and sections of the cable connector assemblies were consumed by the arcing event, which lasted nearly 45 minutes.

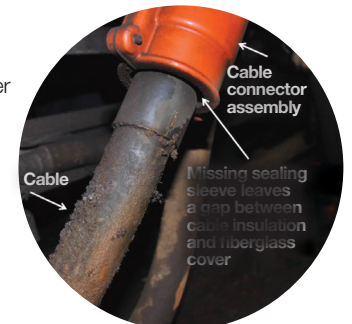
Missing sealing sleeve and resulting gap between cable insulation and fiberglass cover

Sealing sleeves typically are used to keep cable assemblies weathertight in the presence of contaminants and moisture. Although WMATA's engineering design specifications included sealing sleeves, NTSB investigators discovered that the third rail power cable connector assemblies were missing the sealing sleeves that are designed to protect the cable from water and debris.

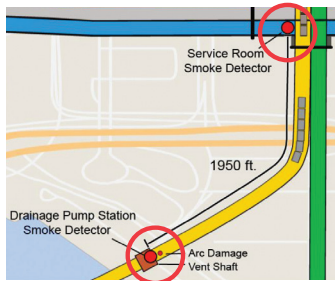
Location of smoke detectors in relation to trains and arc damage

At 3:04 p.m., the first smoke detector was activated. However, notification of this detection was never received by the ROCC or anyone else. The NTSB determined that a loose wire prevented the connection with AIMS, the result of inadequate maintenance.

The NTSB also noted that WMATA lacked the capability to determine the precise location of smoke in the tunnel system since the detectors were spaced too far apart. According to the NTSB, precise location identification of smoke is vital for proper ventilation and survival.

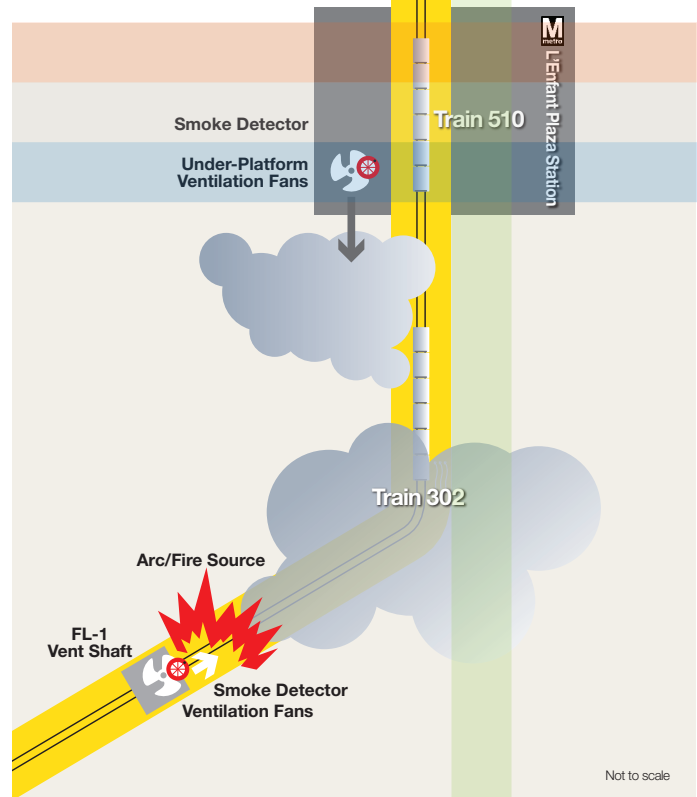
WMATA did not hold any training or develop any procedure to evacuate smoke in train tunnels. Thus, the ROCC train control operator did what seemed best and activated under-platform fans in exhaust mode in the L'Enfant Plaza station, which blanketed train 302 in smoke. It took

Without procedures or system training, the control operator's action to put the fans in exhaust mode blew the smoke toward the train. Since the station fans and ventilation shaft were in exhaust mode, no fresh air supply could be introduced to help move the smoke through the tunnel, toward the outside and away from train 302.

Ineffective ventilation strategy blanketed train 302 in smoke
