District Department of Transportation

Traffic Safety Review

Illinois Avenue between Decatur and Jefferson Streets, NW

June 29, 2015

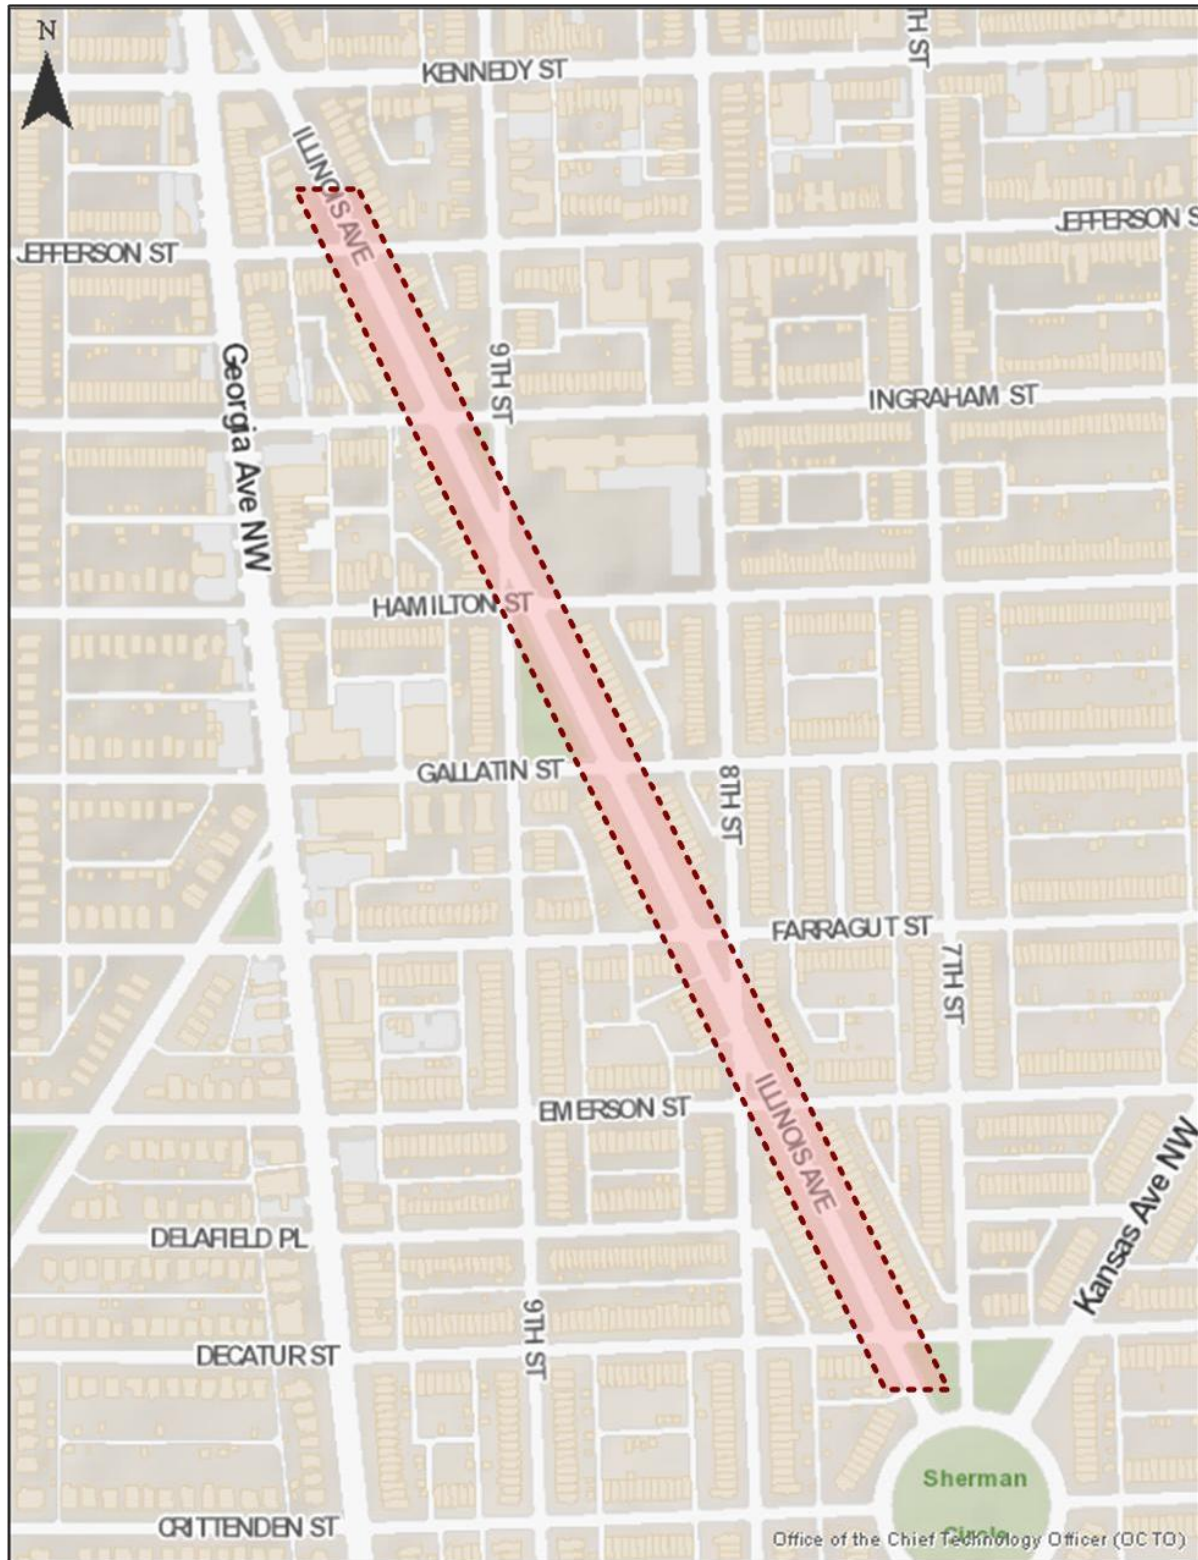
Figure 1: Study Area

The existing study area consists of Illinois Avenue, NW between Decatur Street, NW and Jefferson Street, NW. The corridor is located north of Sherman Circle in the Petworth and Brightwood Park neighborhoods and is approximately one half-mile long. Figure 1 shows the boundaries of the study area.

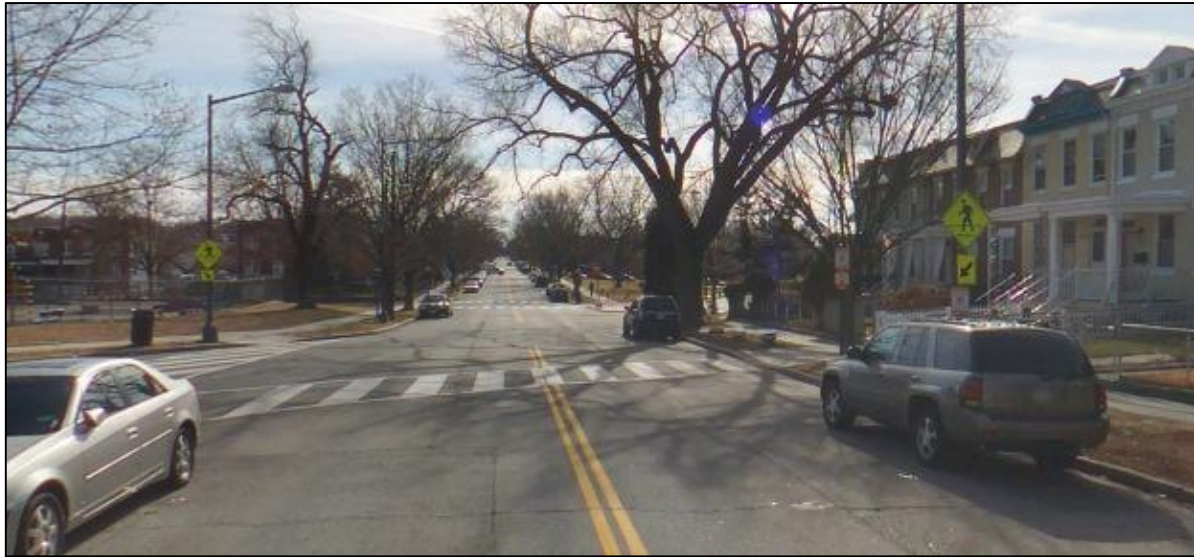
Photo 1: Looking Southbound on Illinois Avenue, NW at 9th Street, NW

Very few pedestrian warning signs are provided along the corridor. At the intersection of Illinois Avenue and 9th Street, NW, one pedestrian warning sign is provided for the crosswalk across the southbound approach of 9th Street, NW and one for the crosswalk across the southeastbound approach of Illinois Avenue, NW, as shown in Photo 1. Additionally, one pedestrian warning sign for a school zone is provided along northwestbound Illinois Avenue, NW, north of Ingraham Street, NW, as shown in Photo 2. An additional sign is provided along southeastbound Illinois Avenue, north of Jefferson Street, NW.

Install pedestrian warning signage (W11-2) with arrow plaques (W16-7P): Existing pedestrian warning signage is only provided at the crosswalk across Illinois Street, NW at 9th Street, NW. It is recommended that additional pedestrian warning signage be installed at each uncontrolled crosswalks at Emerson, Farragut, and Jefferson Streets, NW, as shown on Figure 7.

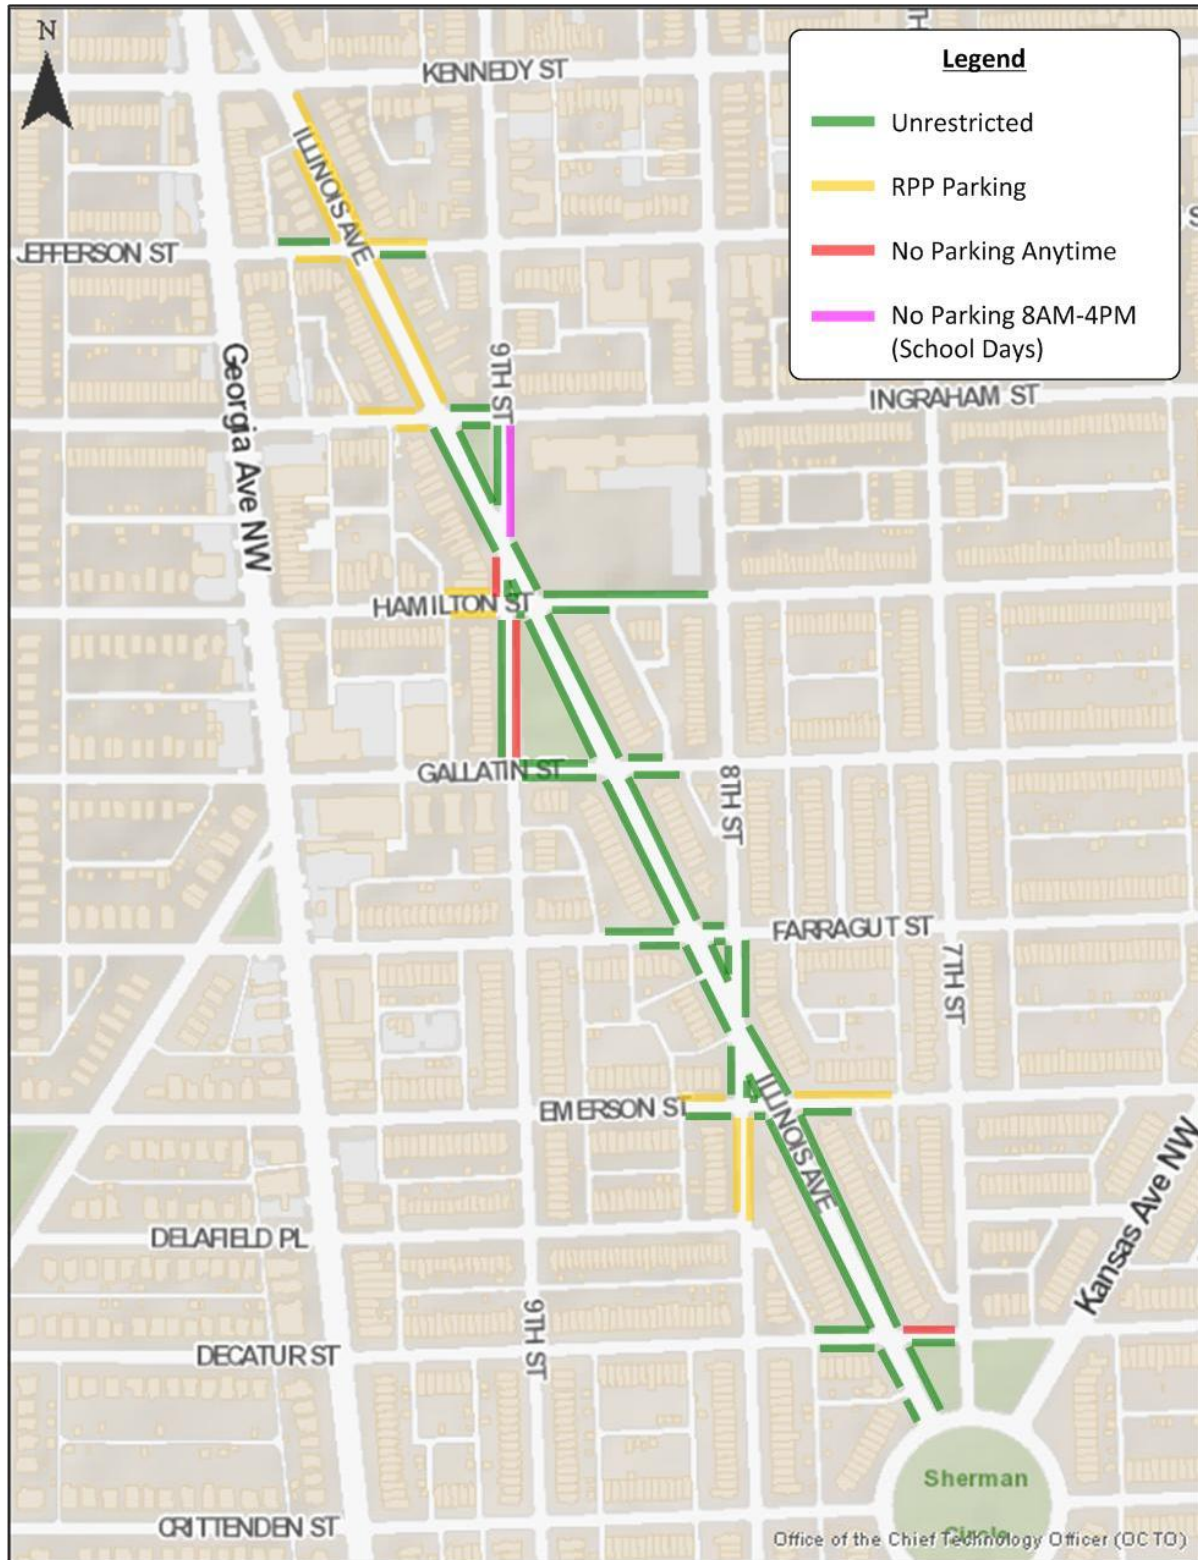
Figure 4: Existing On-Street Parking Regulations

Between Decatur and Ingraham Streets, NW, Illinois Avenue, NW has unrestricted on-street parking. North of Ingraham Street, NW, the on-street parking is restricted to two-hour parking, except for Residential Parking Permit (RPP) holders. The intersecting roadways along the corridor have a mix of unrestricted and RPP (with two-hour or restricted to RPP-only) parking. The existing parking restrictions are shown on Figure 4.

Install parking signs: Signage designating the areas of prohibited parking is not installed on all blocks along the corridor. It is recommended that signage be placed along Illinois Avenue, NW, to designate to drivers where on-street parking is prohibited. Additionally, it is recommended that any parking signage not installed on the side streets within one block of Illinois Avenue, NW be placed. An example is shown on Figure 9.

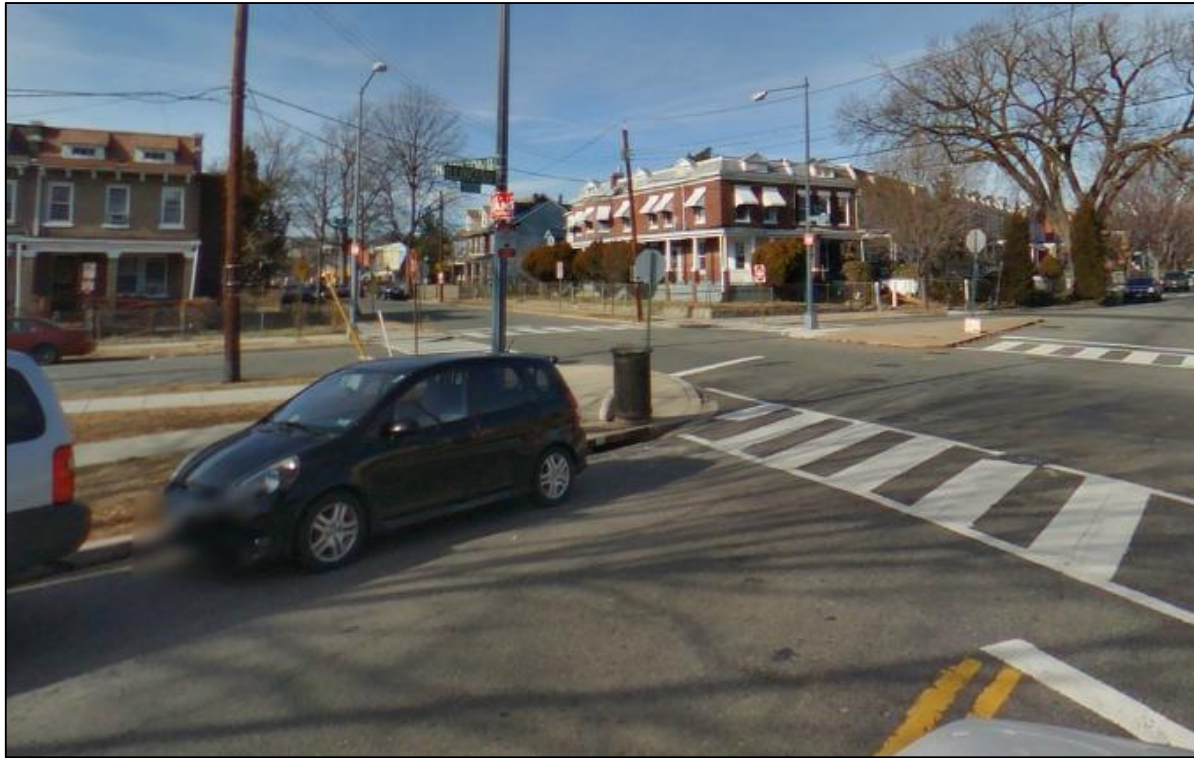
Photo 3: Southwest corner of Illinois Avenue, NW at Hamilton Street, NW

The letter submitted by the Commissioner for ANC 4D-04 noted that drivers park their vehicles too close to the intersections along Illinois Avenue, NW. As shown in Photo 3 and Photo 4 below, the majority of the blocks south of Ingraham Street, NW, where parking is unrestricted, do not have signage denoting the areas where parking is prohibited along the corridor. Vehicles parked in these prohibited areas lead to site distance deficiencies for drivers along the roadway and block the visibility of pedestrians within crosswalks.

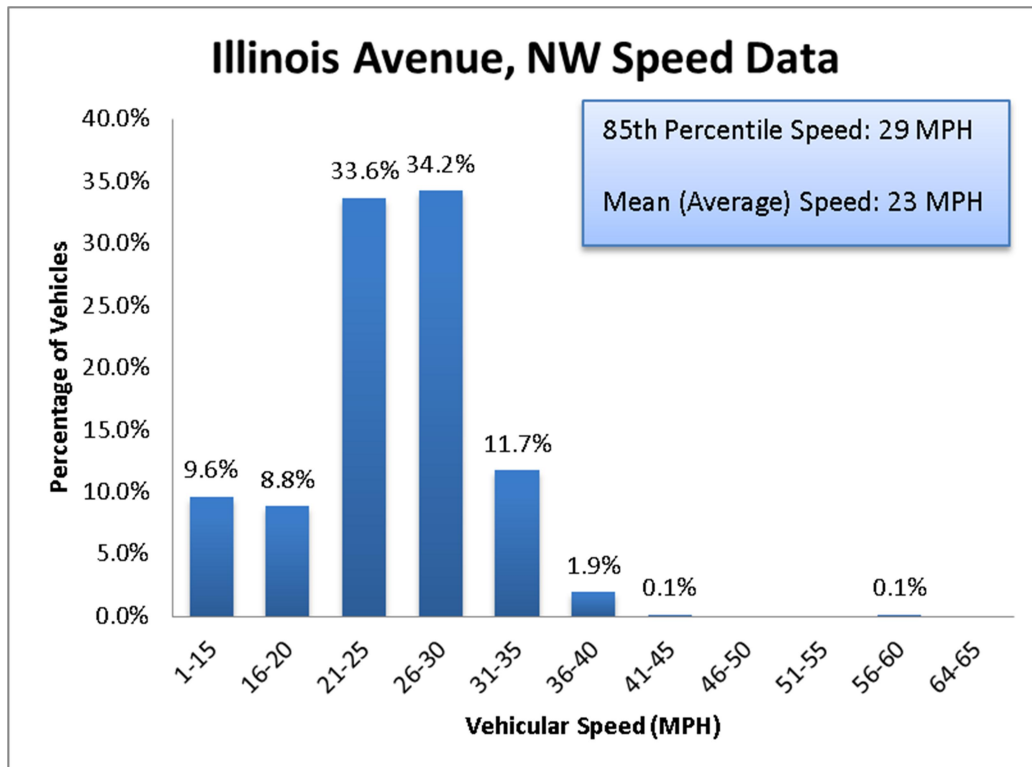
Figure 5: Speed Data on Illinois Avenue, NW

The letter submitted by the Commissioner for ANC 4D-04 noted that drivers speed along Illinois Avenue, NW, especially in between Emerson and Farragut Streets, NW. In order to determine if speeding along the corridor is an existing issue, speed data was collected on Illinois Avenue, NW between Emerson and Farragut Streets, NW on February 19, 2015. The results of the speed study are shown in Figure 5.

As shown on Figure 5, the majority of the drivers on Illinois Avenue, NW travel between 21 and 30 miles per hour (approximately 67.8%). The average speed recorded was 23 miles per hour, and the 85th percentile speed was 29 miles per hour. The speed limit on Illinois Avenue, NW is 25 miles per hour. Thus, the speed data shows that the average speed on Illinois Avenue, NW is less than the speed limit. Additionally, the 85th percentile speed is within an acceptable range for the posted speed.

Of note, the criteria typically employed by DDOT for installation of traffic calming measures requires the measured 85th percentile speed to substantially exceed the posted speed limit, defined as exceeding by at least 25 percent (31 miles per hour in this location). Thus, while the 85th percentile speed is 4 miles per hour above the 25 miles per hour speed limit, this measured speed does not substantially exceed the posted speed limit.
