District Department of Transportation

Roadway Safety Audit Edgewood Road Washington, DC

DDOT Traffic Engineering and Safety Team

September 2, 2014

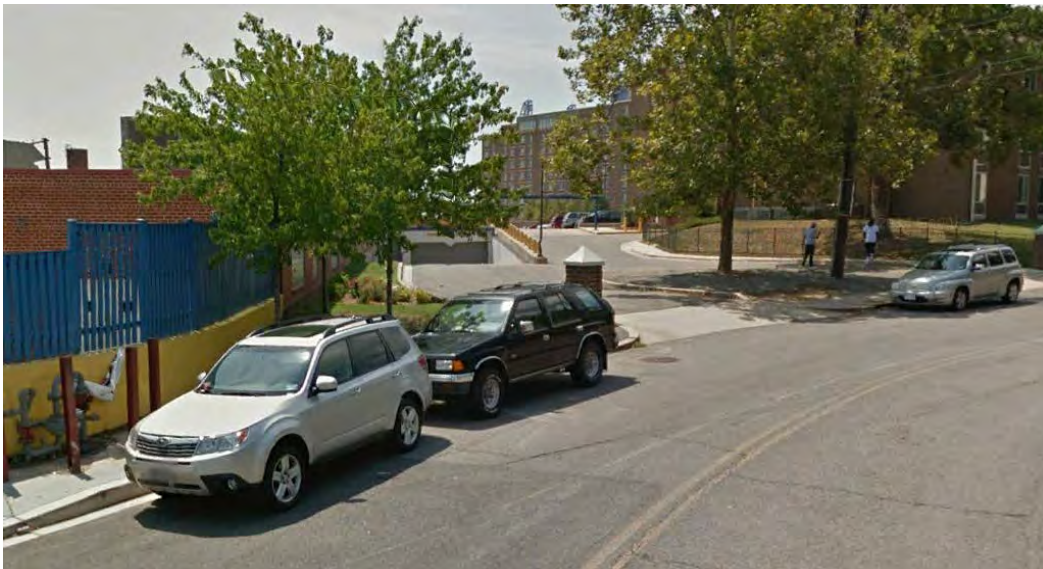
Figure 2 – Illegally Parked Vehicles on Edgewood Street

- On-street parking is prohibited on Edgewood Street at this location. However, several vehicles were observed to park illegally at or near the pedestrian crosswalk. The illegally parked vehicles restrict the available sight distance for motorists to observe pedestrians in crosswalks. This results in pedestrian-vehicular conflicts that impacts traffic safety for school students, particularly during the drop-off and pick-up sessions. **Figure 2** shows several vehicles parked illegally near the existing pedestrian crosswalk.

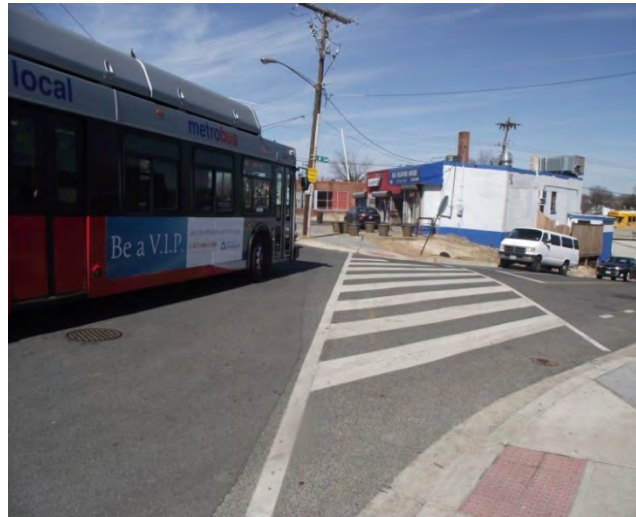
Figure 3 – EB Left Turning Bus Close to Pedestrian Crosswalk

The 7th Street approach presently intersects Edgewood Street at a skewed angle at this location. The skewed roadway geometry in conjunction with the illegally parked vehicles obstruct motorist sight distance which causes eastbound left-turning vehicles, particularly metro transit buses, to partially traverse across the pedestrian crosswalk on the east leg of the study intersection. This creates conflicts between eastbound left-turning vehicles and pedestrians, especially school students and crossing guards, are traversing in the crosswalk. **Figure 3** shows eastbound left-turning metro bus traversing in close vicinity of the crosswalk.

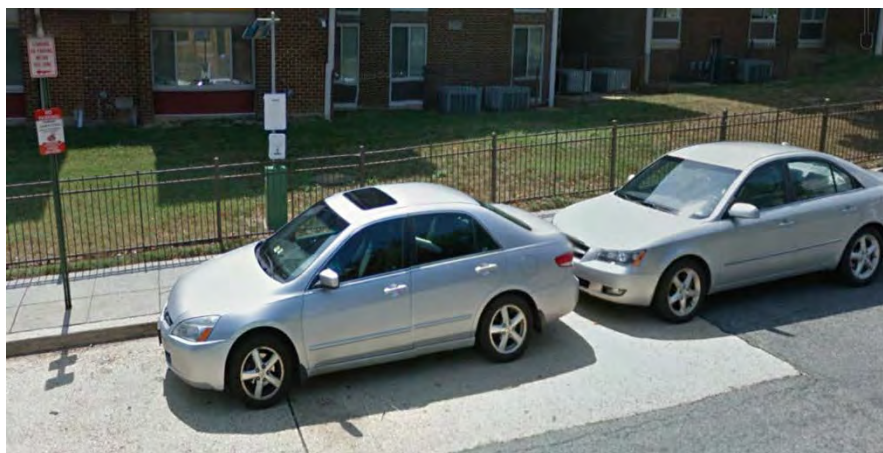
Figure 4 – Illegally Parked and Standing Vehicles on Bus Pad

- There are parking restriction signs on Edgewood Street that prohibit parking in a bus zone. However, as shown in **Figure 4**, motorists were observed to parking and standing illegally in the bus zone. Further, the RSA team also observed parents illegally standing and parking their vehicles in the bus pad for drop-off purposes during the morning peak-hour. This creates direct conflicts between Metro bus operations and vehicles that are illegally parked and standing on the bus pad.

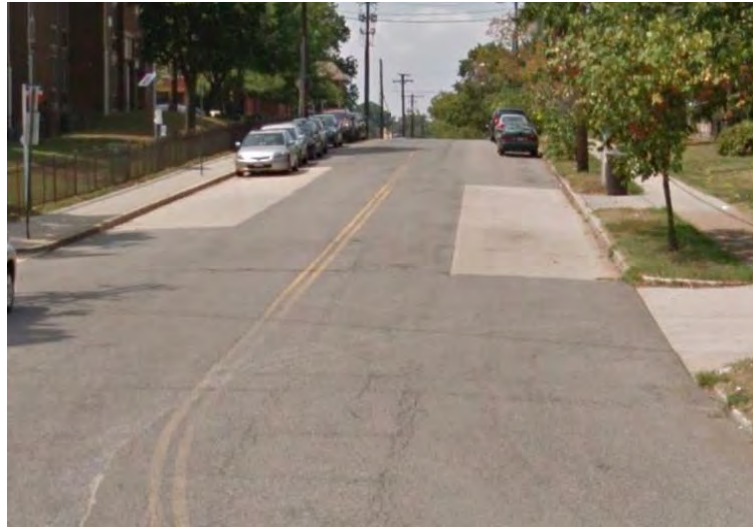
Figure 5 – Existing Bus Stops on Edgewood Street

- There are two bus stops on both sides of Edgewood Street at this location. However, there are no crosswalks to provide safe pedestrian access to these bus stops. As such, transit riders are regularly exposed to the oncoming vehicular traffic when crossing Edgewood Street to take the metro bus. This creates significant pedestrian safety issues, especially during the morning and evening peak hours when southbound vehicles are traversing at higher speeds. **Figure 5** shows the location of two existing bus stops on Edgewood Street.

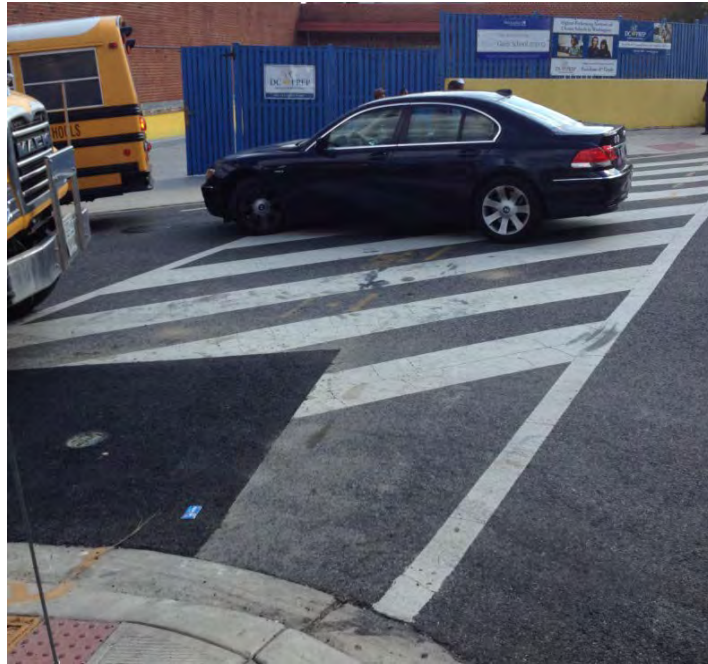
Figure 6 – Motorist Blocking Pedestrian Crosswalk

- Motorists routinely fail to yield to pedestrians in the crosswalk. Vehicles block the pedestrian crosswalk during the morning drop-off and afternoon pick-up sessions. This creates direct pedestrian-vehicular conflicts as pedestrians, especially school students, are forced to go around the stopped vehicles in the crosswalk. **Figure 6** shows motorist blocking the pedestrian crosswalk at this location.

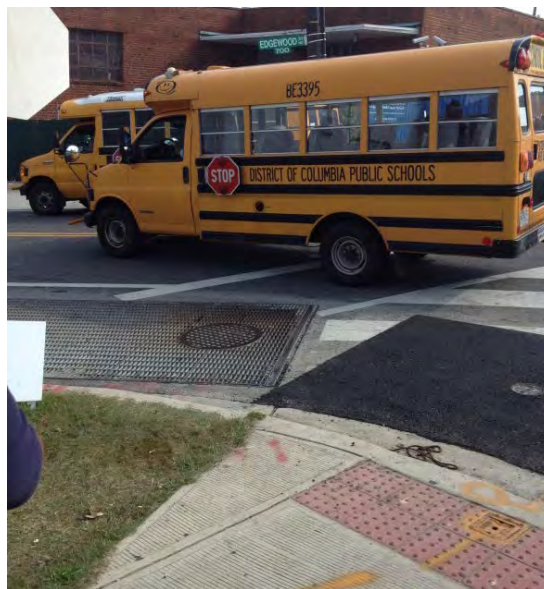
Figure 7 – School Bus in Wrong Lane

- The RSA team also observed a few motorists, especially school buses, traveling in the wrong travel lanes. This deliberate motorist behavior of driving in the wrong travel lanes, significantly increases the potential for head-on collisions, injury-related crashes and fatal crashes. **Figure 7** shows school buses traveling in the wrong travel lanes at this location.

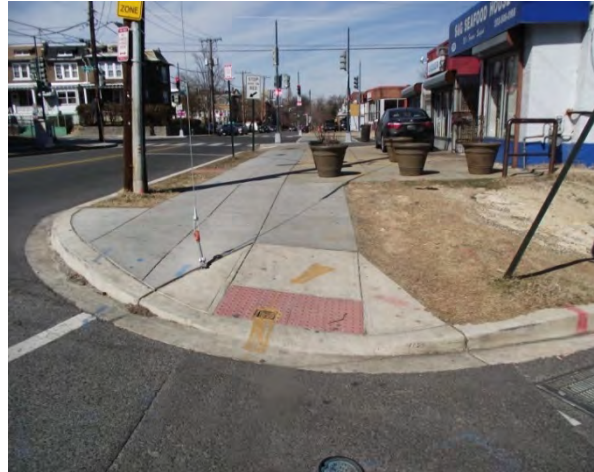
Figure 8 – Non-Standard Pedestrian Ramp

- The pedestrian ramps do not meet the ADA specifications at this location; as they are too steep and have non-standard dimensions. Further, the counter slopes for gutter are too steep and the turning spaces are inadequate. The non-standard pedestrian ramps create safety hazards for the wheelchair users at this location. **Figure 8** shows the existing pedestrian ramp which is not in compliance with the ADA requirements.

- The traffic control signs are either damaged or incorrectly mounted at this location (as shown in **Figure 8**). Further, there are no advance warning signs for the school zone installed at this location. The pavement markings for the existing crosswalk are faded and need to be replaced.
- The utility pole is installed very close to the pedestrian ramp, as shown in **Figure 9**. The utility poles obstruct access, especially for wheelchair users, to pedestrian facilities. It should also be noted that the sidewalk is very narrow at the terminus of the pedestrian ramp, and there is not enough turning space for wheelchair users to maneuver after leaving the crosswalk.

Most of the pedestrian facilities in the study area do not meet the specifications for ADA compliance. The ramps and gutter counter slopes are steep and there is not adequate turning space for pedestrians, particularly wheel chair users. Further, curb ramps are completely missing at some crosswalks. Hence, the pedestrian facilities in the study area should be removed and replaced with new pedestrian facilities that are in compliance with the new ADA specifications.

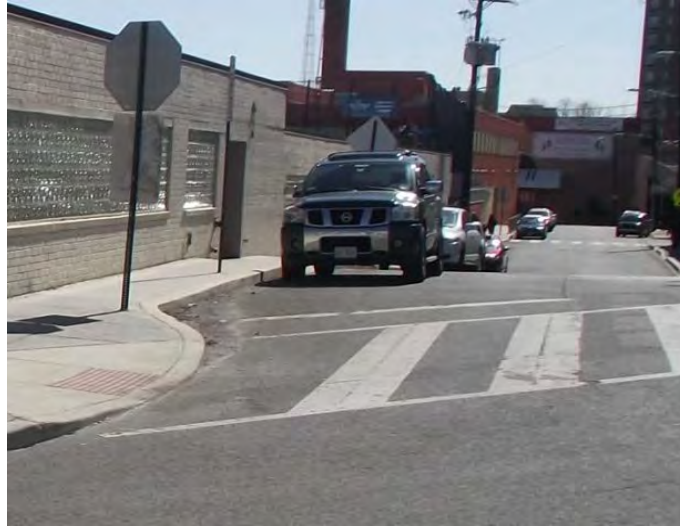
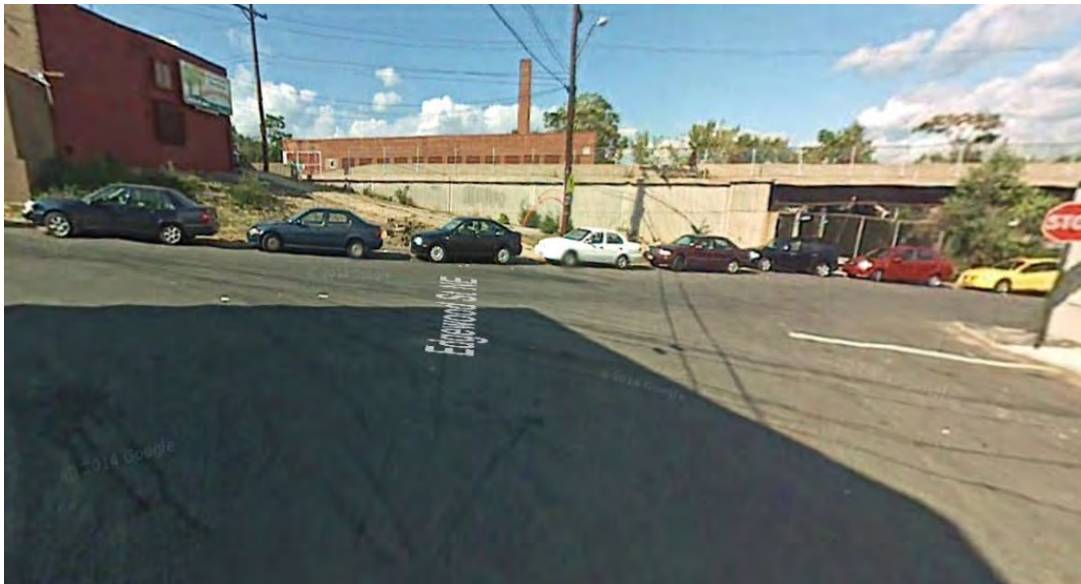
- On-street parking is prohibited on both Edgewood Street and the school access roadway at this location. However, several motorists illegally park their vehicles for drop-off and pick-up purposes during the morning and afternoon peaks.
- The drop-off and pick-up areas are also not clearly defined which compounds the practice of parents parking their vehicles illegally to escort their students into the schools. In addition, the motorists have to make a 3-point turn maneuver for exiting because of the narrow width of the school alley. This creates direct conflicts between motorists and pedestrians, particularly school students at this location. **Figures 10 and 11** show illegally parked vehicles at this location.

Figure 10 – Illegally Parked Vehicles

Figure 11 – Illegally Parked Vehicles

- **Install new parking restriction signs, "No Parking Or Standing Anytime", on the north side of Edgewood Street at school access location**
- **Increase MPD Enforcement on Edgewood Street, particularly during drop-off and pick-up sessions**
- **Convert traffic flow on Edgewood Street to One-Way in the Eastbound direction between 7th Street and Franklin Street Overpass during school drop-off and pick-up sessions only**

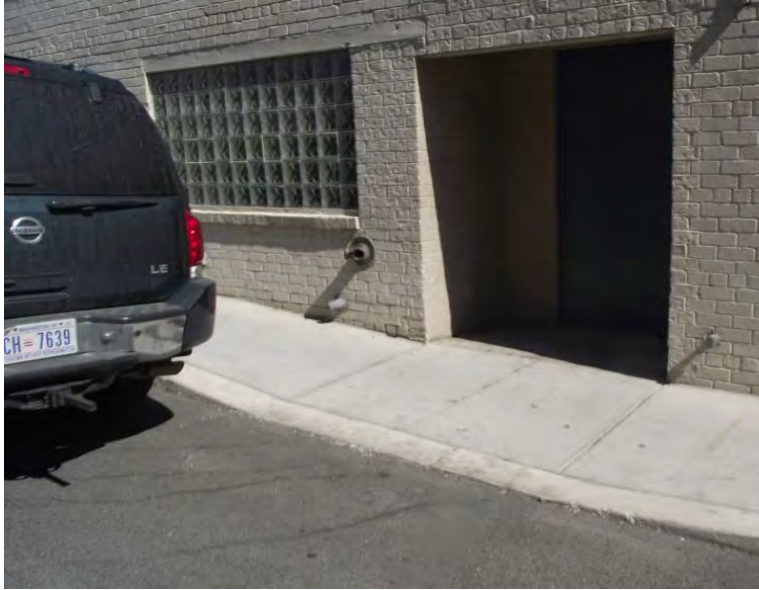
Figure 12 – Non-Standard Pedestrian Ramp at School Entrance

- The schools have constructed pedestrian ramps at their entrance doors that do not meet the current ADA specifications. As shown in **Figure 12**, the pedestrian ramps have sub-standard landing areas and the cross slopes do not meet any ADA guidelines.
- Furthermore, there are no parking restriction signs that prohibit vehicular parking in the vicinity of the pedestrian ramps at this location. **Figure 12** shows motorist parked immediately adjacent to the pedestrian ramp at the school entrance. The non-standard pedestrian ramps, in conjunction with illicit vehicular parking, create safety issues for school students.

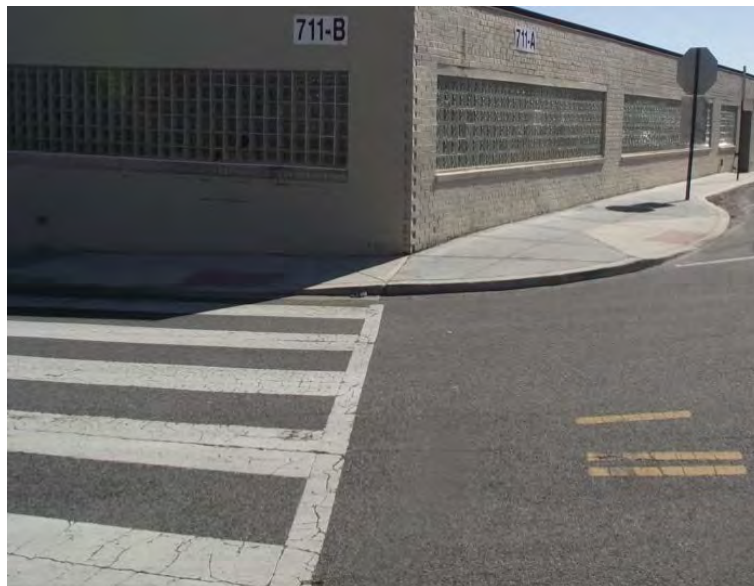
Figure 13 – Narrow Sidewalks at Pedestrian Ramp

- The sidewalks are either narrow or missing at the pedestrian ramps, as shown in **Figure 13**, at this location. Hence, there is not sufficient turning space for wheelchair users to maneuver after leaving the crosswalk. The landing area in the pedestrian ramp is damaged and needs repairs.

- The pavement markings at existing crosswalks, as shown in **Figure 13**, are faded and need to be replaced with new markings. A few school signs are either damaged or worn-out at this location and should be replaced with new school signs.

Most of the pedestrian crosswalks in the study area are faded, damaged or completely missing. This impacts visibility of pedestrians, particularly students, during inclement weather and low visibility conditions. Hence, all the damaged crosswalks should be removed and replaced with high-visibility ladder-type crosswalks in the study area.

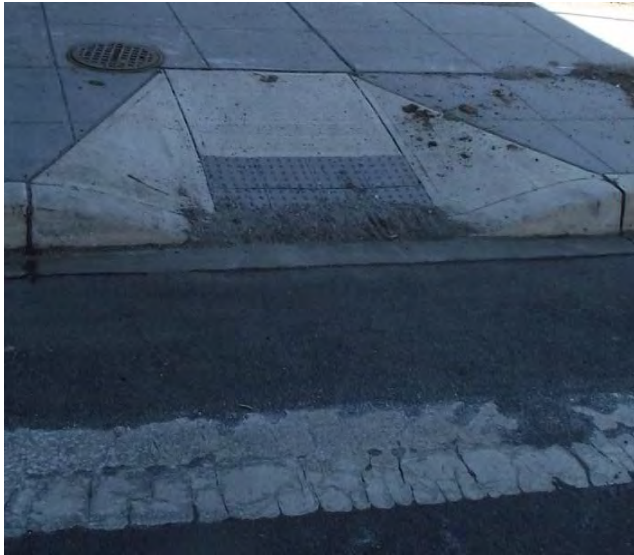
Figure 14 – Non-Standard Pedestrian Ramp

- Edgewood Street transitions to 8th Street, NE underneath the Franklin Street Overpass. There are two pedestrian crosswalks at this location. The pedestrian ramps at both crosswalks are non-standard and do not meet any ADA specifications.
- The landing areas at ramps are either missing or damaged. Further, the cross slopes are steep which create safety hazards for pedestrians, particularly wheelchair users. **Figure 14** and **Figure 15** show the non-standard and damaged ramps, respectively at this location.

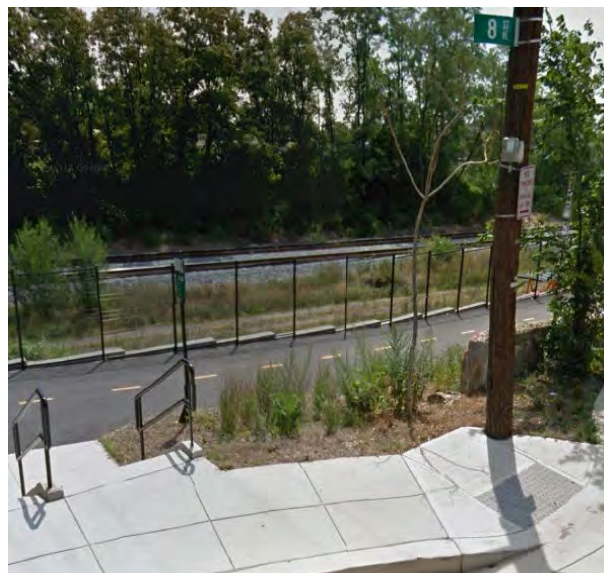
Figure 16 – Improper Pedestrian Ramp to MB Trail

- There is a utility pole in the middle of the curb ramp to the Metropolitan Branch (MB) Trail at this location. The ramp is non-standard and does not meet ADA specifications. Further, the ramp is not aligned properly with the opposite pedestrian ramp which creates safety hazards for pedestrians with disabilities. **Figure 16** shows the improperly installed pedestrian ramp.

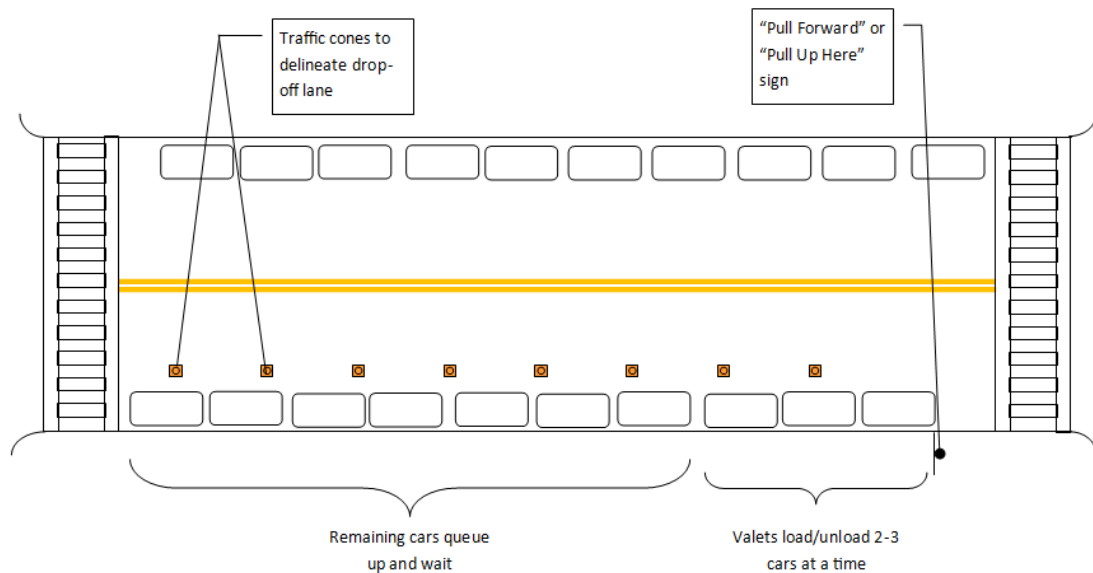
Figure 17 School Valet Layout

- Schools should coordinate with MPD for enforcement and issuing warnings or tickets
- The school valet area should be delineated by using appropriate traffic signs and traffic control devices. Some schools put out cones to delineate the drop-off only lane as shown in the **Figure 17**. The cones are placed between the drop-off lane and the travel lane. The idea is that parents pull in at one end of the drop-off lane, and leave from the front. Parents are not allowed to enter or leave the drop-off lane anywhere in the middle and are instructed to stay close to the car in front of them. Putting a “Pull Forward” or “Pull Up Here” sign at the very front of the drop-off/pick-up area is also helpful to show parents where to stop. Position the valets near this location.
